# Manhole Inspection Summary

Manhole # S15II1001MH

**Inspection** ☐ Is Incomplete Rating: **4) Poor**

**Location** Address: **2512 PARK HEIGHTS TERR**

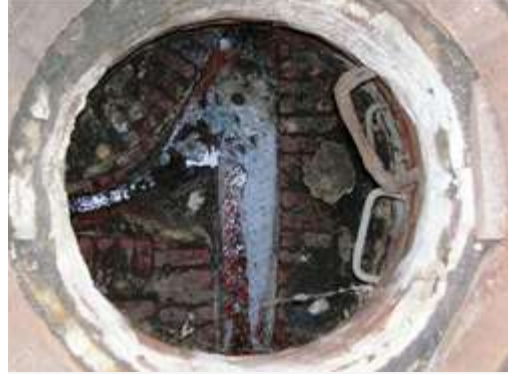
Top View

Corrded steps. Evidence of surcharge - Bench debris. Channel debris.

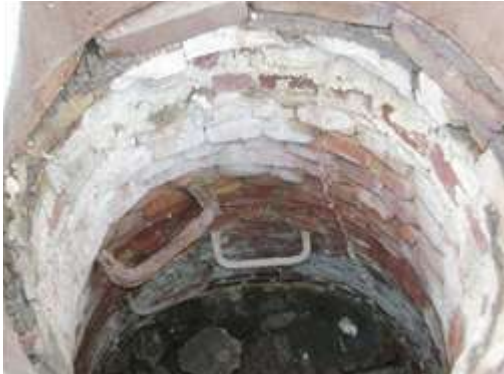
Defect

Frame leaks. Adjustment loose brick, deterioration and infiltration. Corbel and Barrel deterioration and infiltration - other

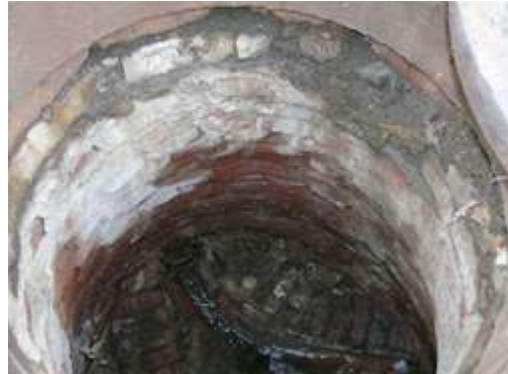
Defect

Frame leaks. Adjustment loose brick, deterioration and infiltration. Corbel and Barrel infiltration.

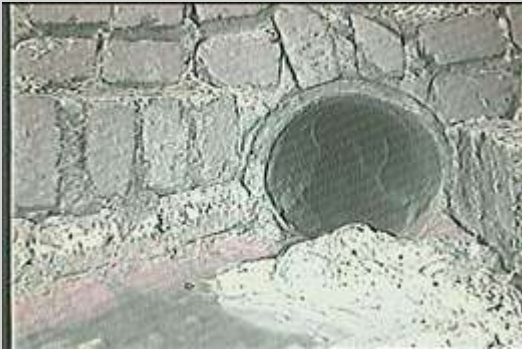
### 8 in. Circular Gravity Sewer Pipe Out @ 12 O'Clock

Barrel deterioration and infiltration. Channel deterioration.

Infiltration: **Evidence** Pipe Seal Cond: **Cracked**

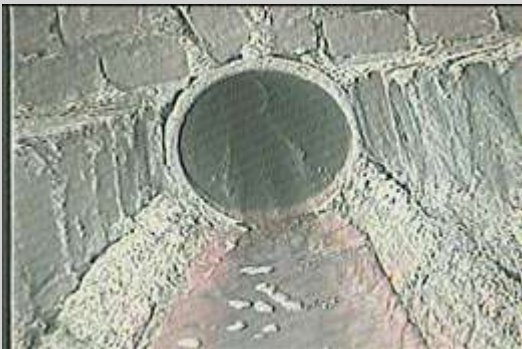
### 8 in. Circular Gravity Sewer Pipe In @ 6 O'Clock

Infiltration: **Evidence** Pipe Seal Cond: **Unknown**

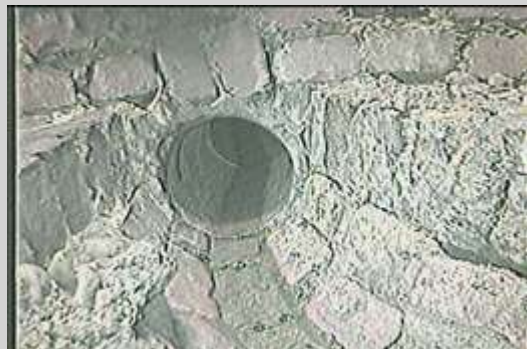
Pipe In @ 9 O'Clock

Barrel deterioration and infiltration. Channel deterioration.

Pipe Seal Cond: **Cracked**
